**APPENDIX K**  
**DRINKING WATER AND SEWER SYSTEMS**

# **DRINKING WATER AND SEWER SYSTEMS**

**MICHEL P.H. BRONGERS<sup>1</sup>**

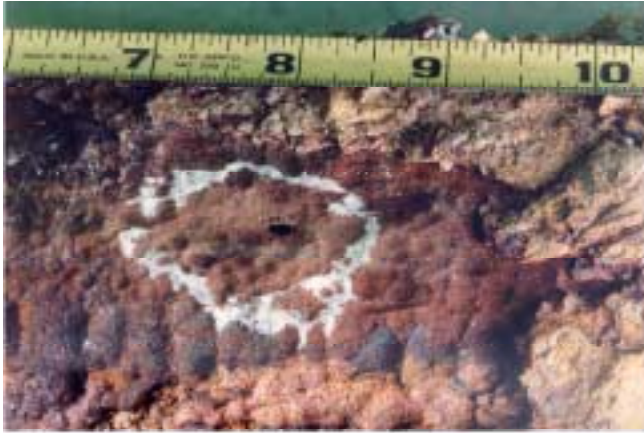
External corrosion on ductile iron pipe

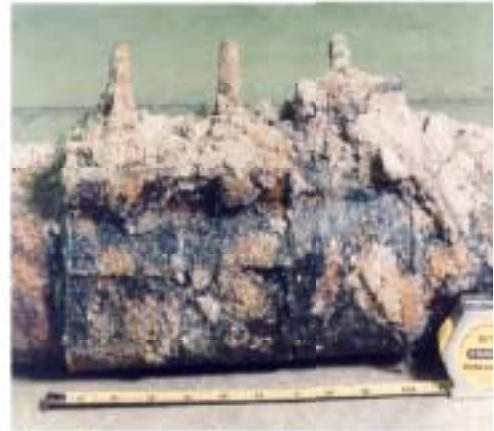
Two clamps on water main

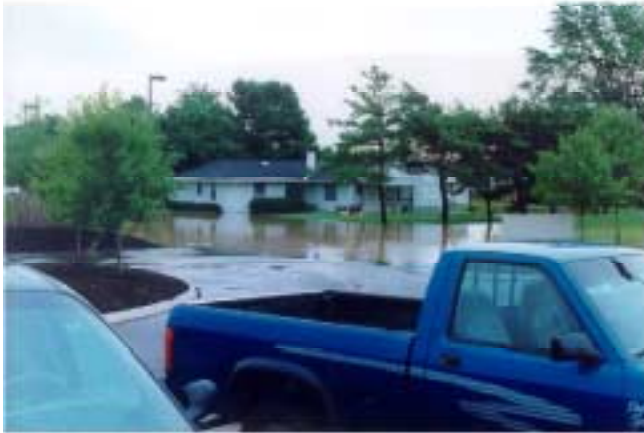
Water main break

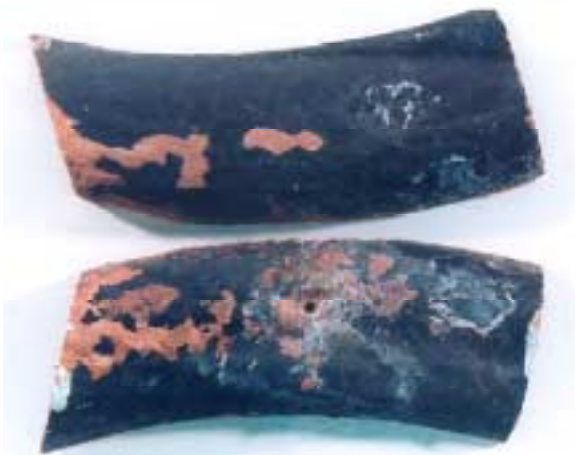
Pit in copper tubing

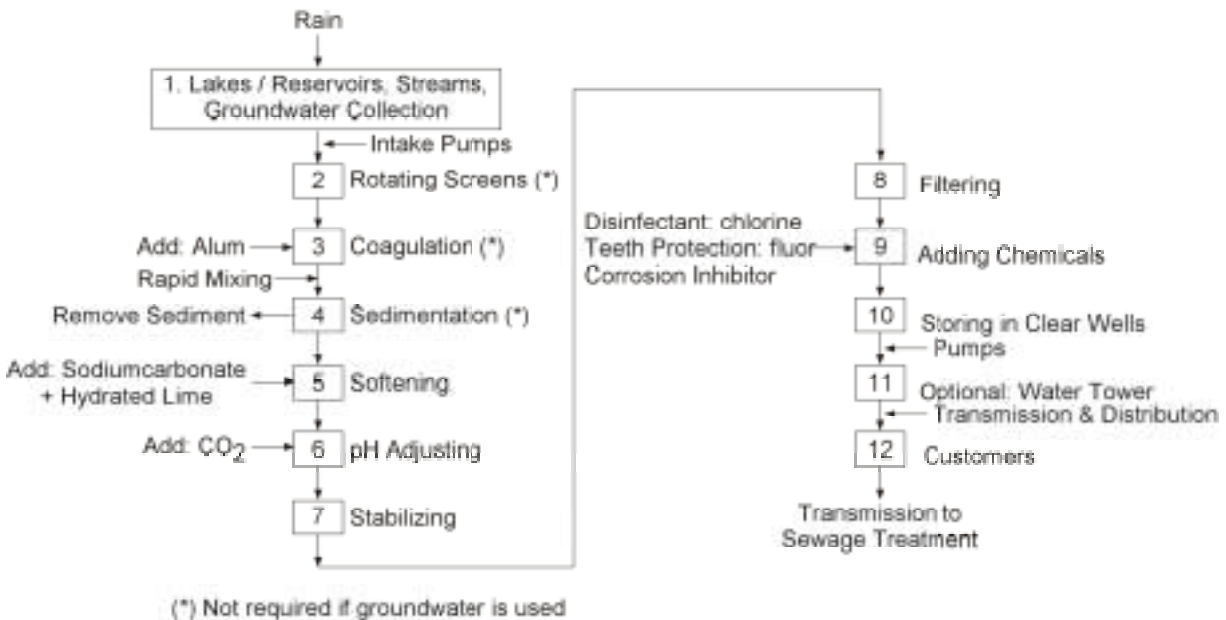
The infrastructure of water treatment facilities is designed to remove contaminants from water. Figure 1 shows a schematic diagram of the drinking water treatment process.

Figure 1. Schematic diagram of drinking water treatment process.

A series of filtration procedures and several chemical treatments are used in cleaning the raw water to prepare it for consumption. Mixing of different source waters is often used as an option to change quality and reduce corrosivity. In some cases, aeration can be used in drinking water treatment. In addition to removing hydrogen sulfide, methane, radon, iron, manganese, and volatile organic contaminants, aeration is effective for carbon dioxide ( $\text{CO}_2$ ) removal.  $\text{CO}_2$ , in turn, directly affects pH and dissolved inorganic carbon, two parameters that significantly influence lead and copper solubility. Under the right water quality conditions, aeration can serve as a potential corrosion control treatment by removing  $\text{CO}_2$  and subsequently increasing pH and decreasing dissolved inorganic carbon. The degree to which aeration affects corrosion depends on such raw water quality parameters as pH, dissolved inorganic carbon, and dissolved oxygen, as well as  $\text{CO}_2$  removal efficiency.<sup>(22)</sup>

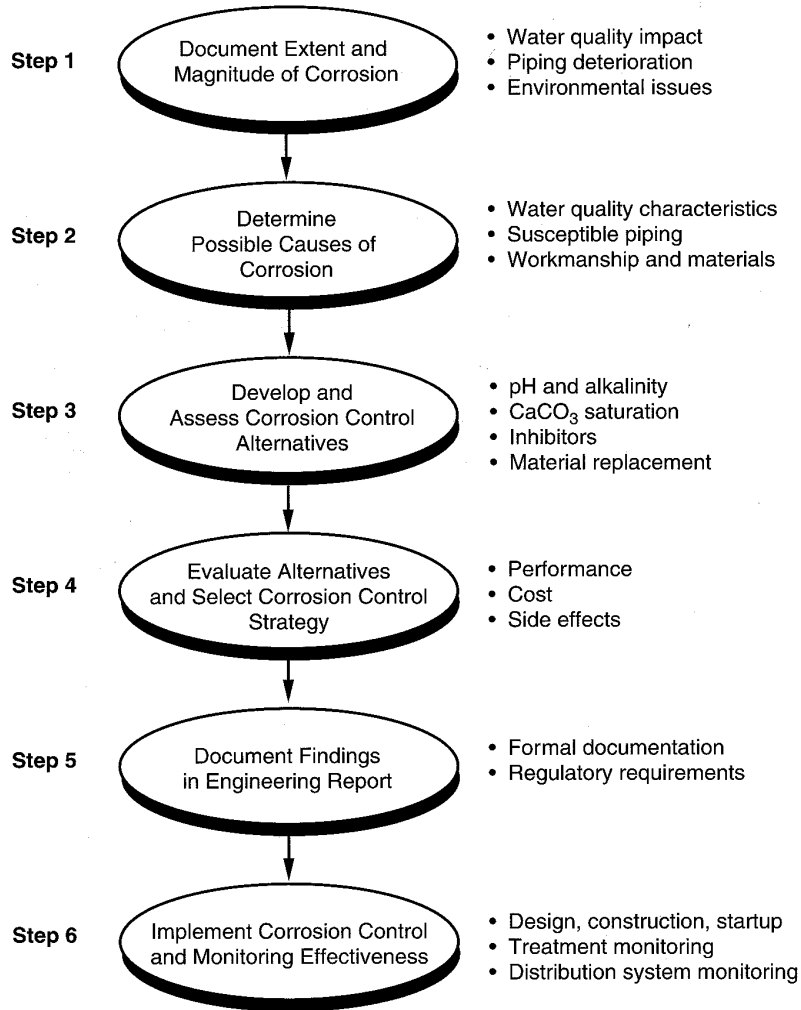
Figure 3. Corrosion control program implementation flowchart for internal corrosion.<sup>(20)</sup>

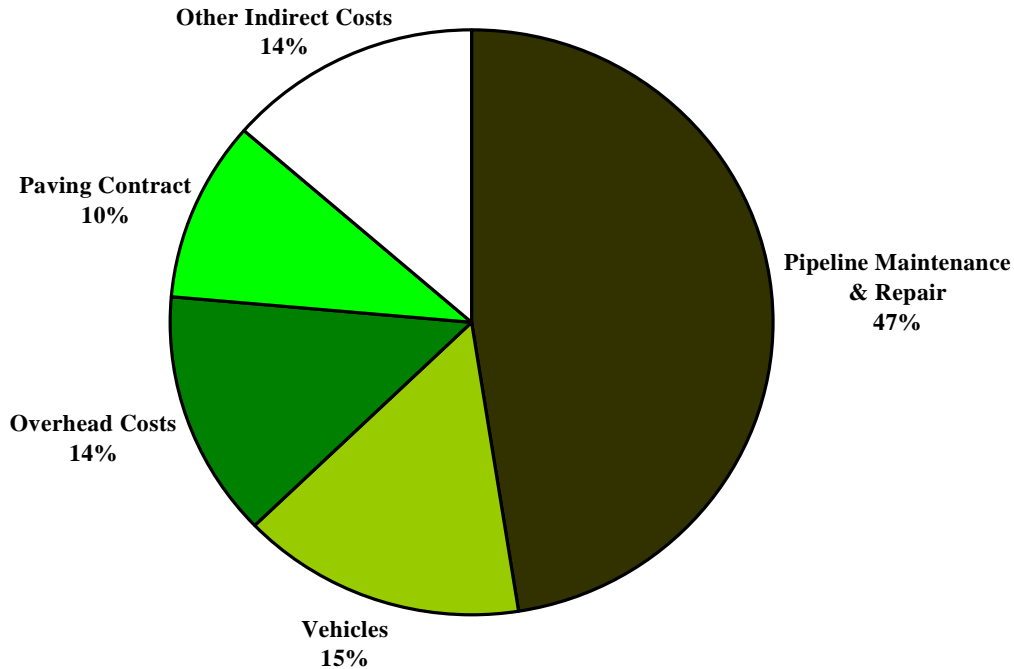
This figure shows that the direct costs of maintenance and repair (\$724,000) and paving (\$150,000) were roughly 57 percent of the total costs. The indirect costs of vehicles (\$232,000), overhead (\$211,000), and other indirect costs (\$209,000) were roughly 43 percent of the total costs.

Figure 4. Pipeline repair costs for Marin Municipal Water District from 1992 to 1993, as reported by Harrington.<sup>(38)</sup>

In 1993, Harrington<sup>(38)</sup> reported on methods to manage a corrosion control program. He presented 1992 to 1993 data showing a breakdown of water system leak repair costs and the resultant cost per average repair for the Marin Municipal Water District in California (see figure 4). For this chart, a total of 420 leaks were analyzed at an average repair cost of \$3,640 per leak.

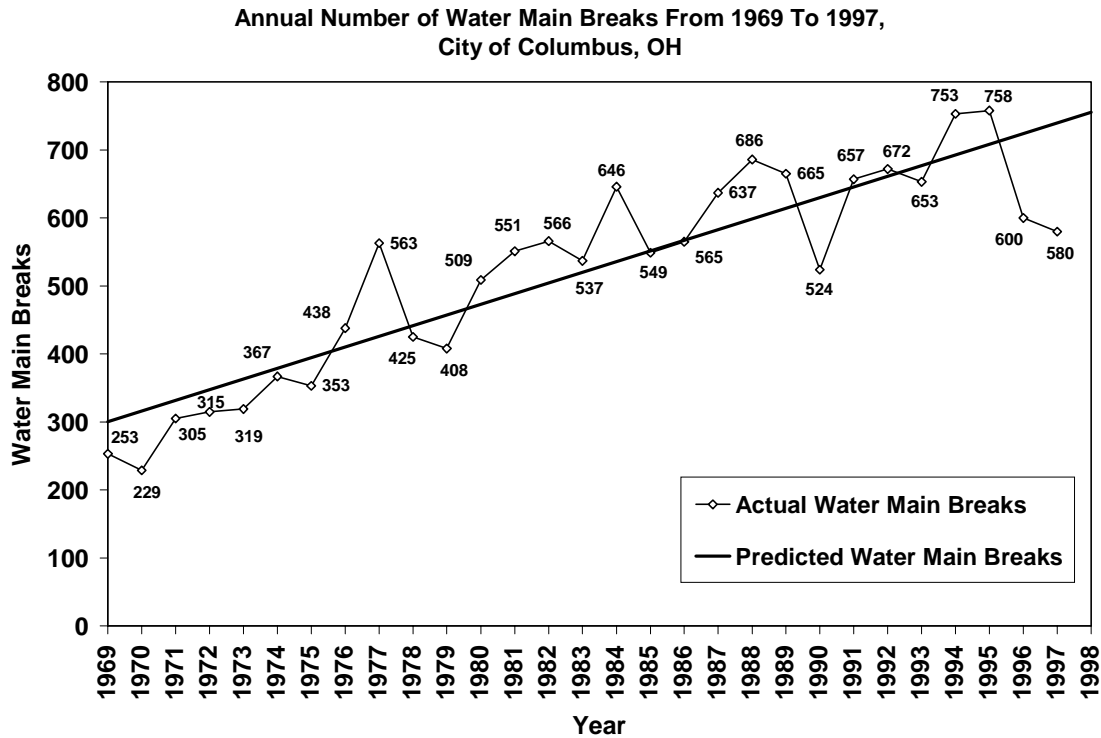
The city of Columbus, with approximately 1 million inhabitants, averages 500 to 800 significant water pipe breaks each year. Figure 7 shows that during the last 25 years, the number of line breaks is consistently rising. This increase in the annual number of main line breaks can most likely be attributed to the system's increasing size and age. Although Columbus consistently fixes these leaks at an approximate total annual cost of \$9 million, the percentage of unaccounted-for water did not decrease during the last 25 years. If the leaks are detected and fixed earlier, the capacity of treatment facilities could be considerably smaller, contributing to greater efficiency and extra profitability for the system.

Figure 7. Number of actual and predicted water main breaks from 1969 to 1997 for the city of Columbus, OH.<sup>(18)</sup>
